Athena Statue Restoration Report

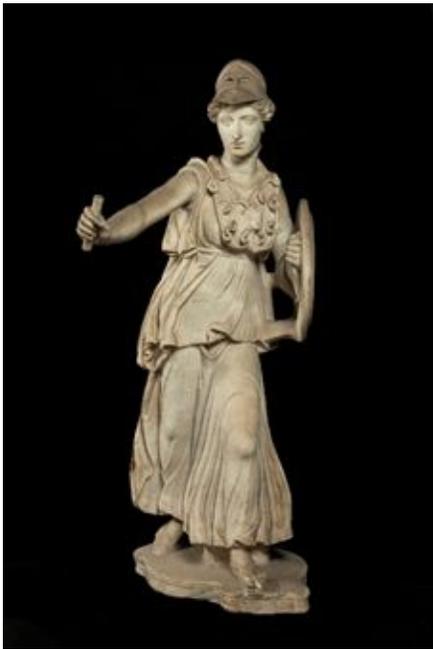
Before Restoration

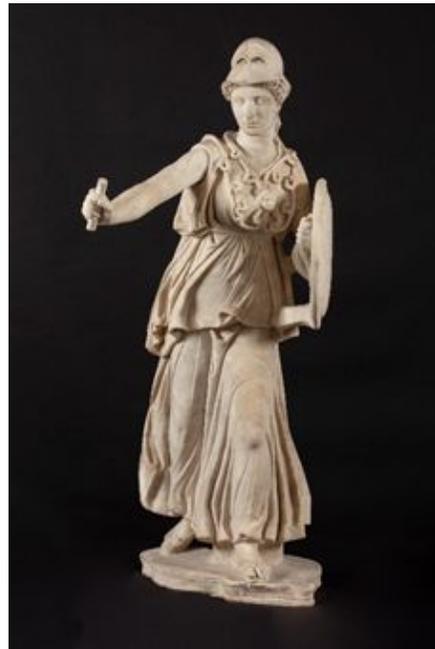
After Restoration

The restoration intervention of the work was completed in the month of November 2020 and the restored Athena provides a more balanced reading. This gives more continuity between the different marble inserts of which the statue is composed: original elements in Pentelic marble and irrelevant elements in Luna marble.

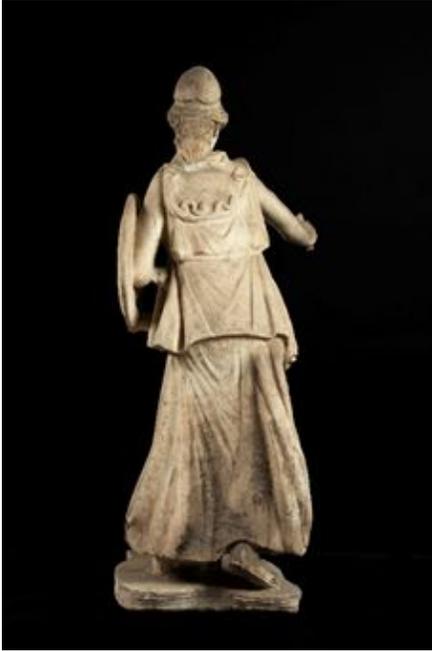
Before Restoration

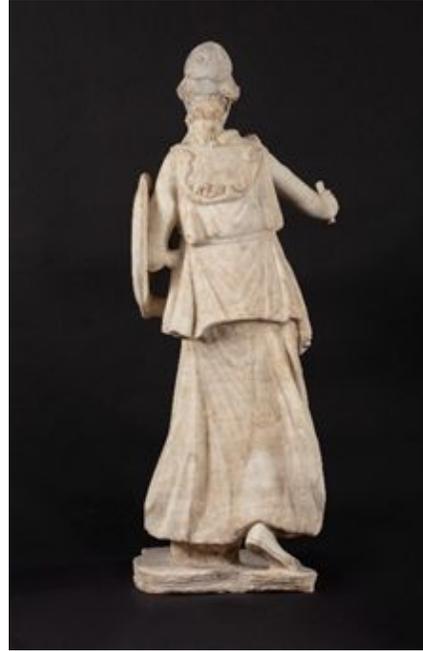
After Restoration

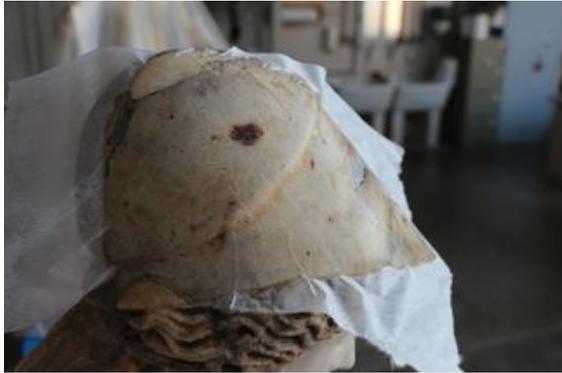
Application of Japanese paper

After having freed the surface of the first layer of the particles, several cleaning tests were carried out with applications of Agar-Agar and/or Japanese paper, varying the laying time (from 5 minutes to 2 hours).

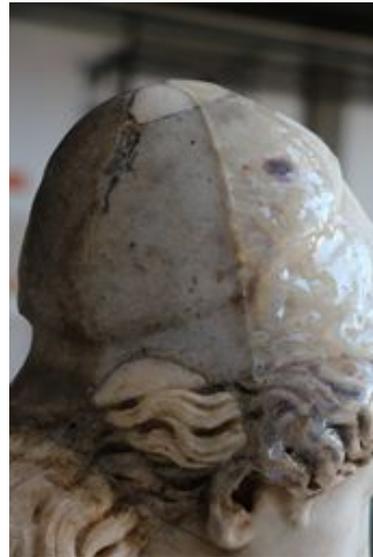
Application of Agar-Agar

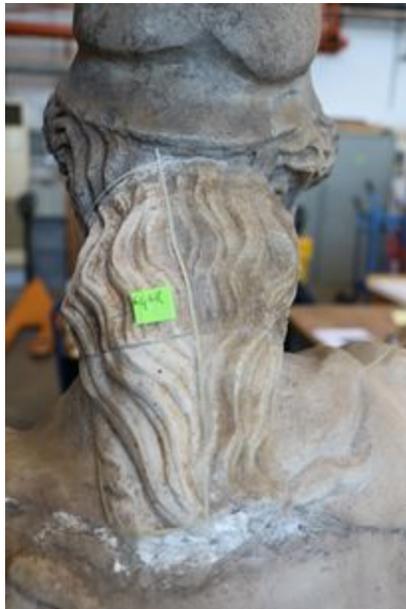
Removal of the particles after the tests

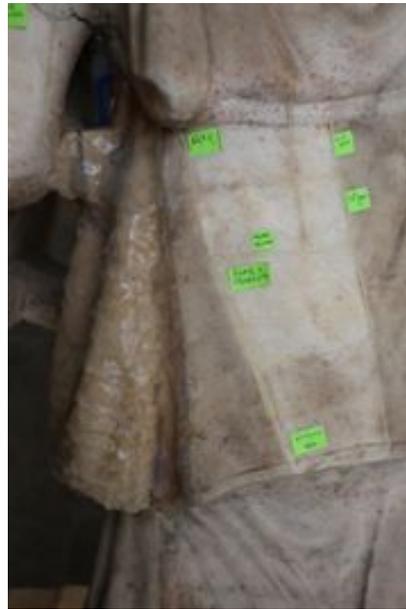
Varied types of cleaning tests

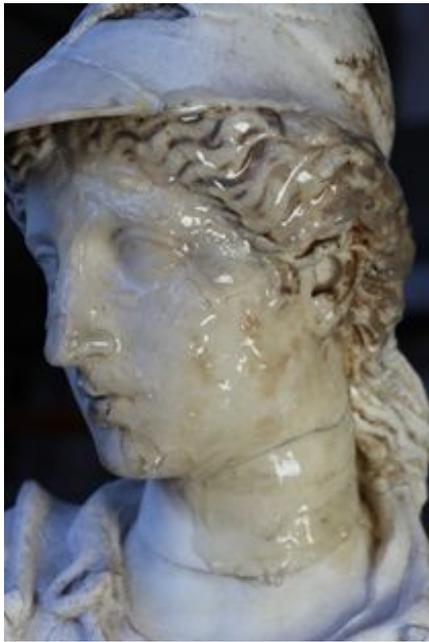
Agar-Agar Cleaning

The total cleaning was performed in respect to the original patina and to the subtle traces of red and brown coloring that were found in some locks of the hair and behind the lobes.

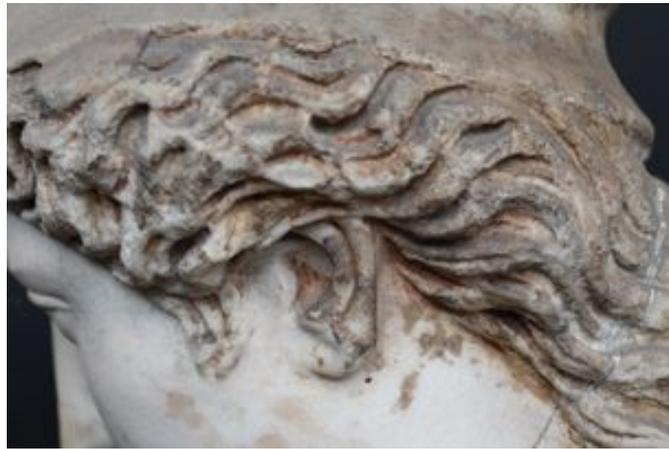
Traces of red and brown coloring

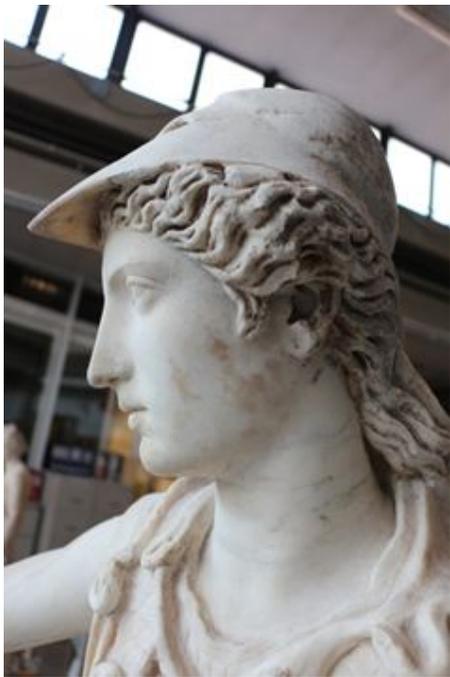
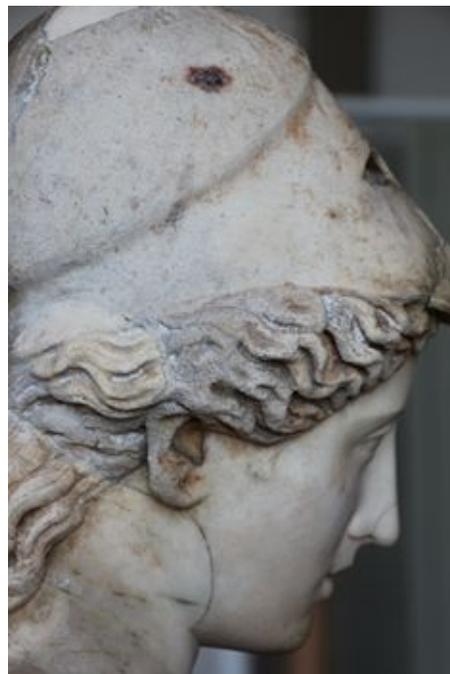
After the cleaning with Agar-Agar

The cleaning with the Agar-Agar has allowed a removal of the coherent and incoherent deposits respecting the “noble patina” on the marbled surfaces.

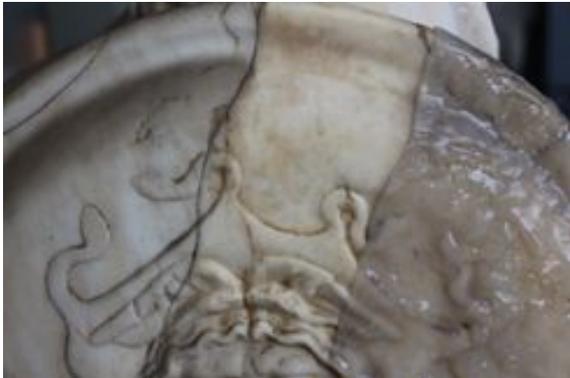
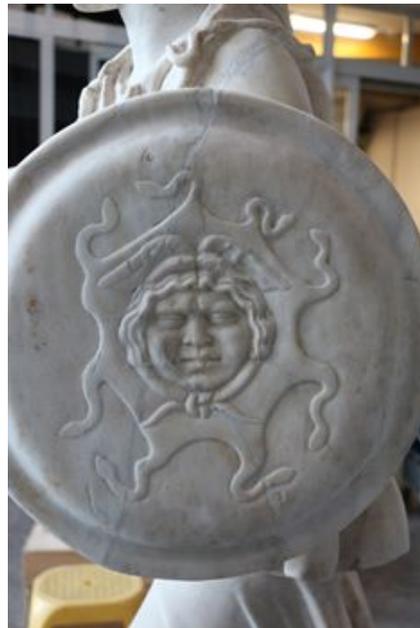
During and after the cleaning

After cleaning with Agar-Agar, the surface was treated with a pad soaked in White Spirit, removing any residue from the support.

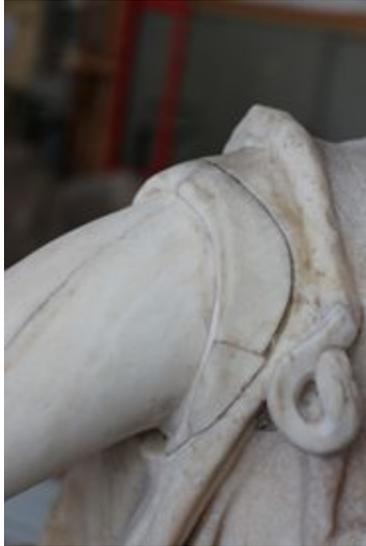
Before

At the end of the cleaning, the grouting was carried out and all of the cracks were sealed with mortar made of sifted marble powder and lime putty. The gaps were filled in and, where necessary, glazed with watercolors.

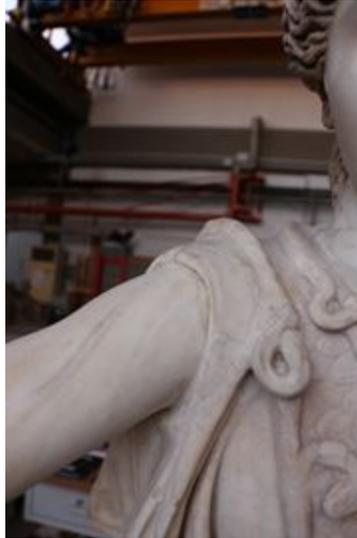
After

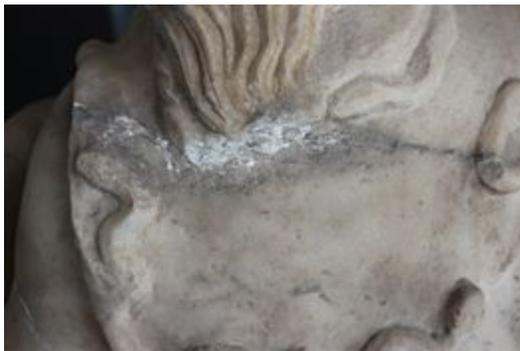
Before

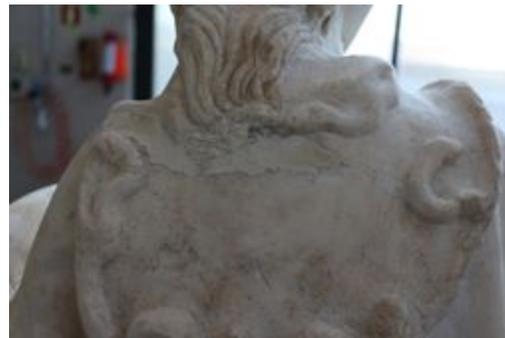
After

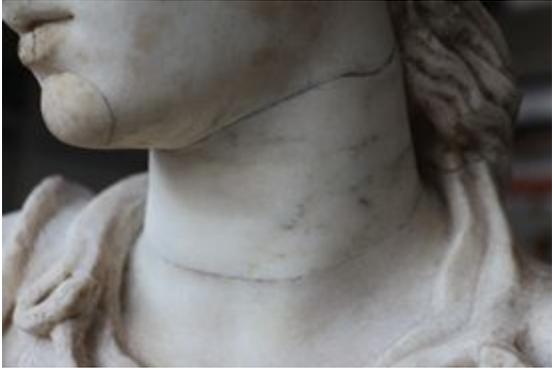
Before

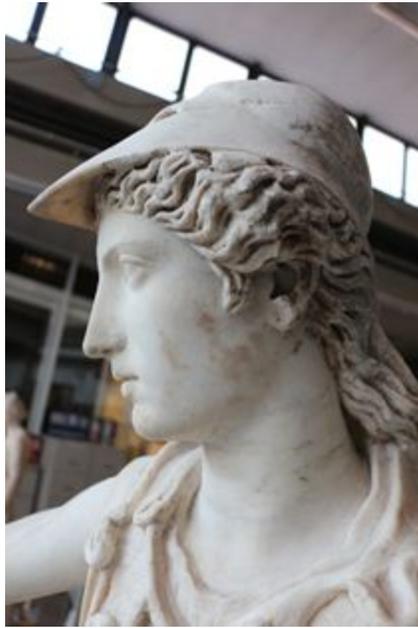
After
