Athena Statue Restoration Report

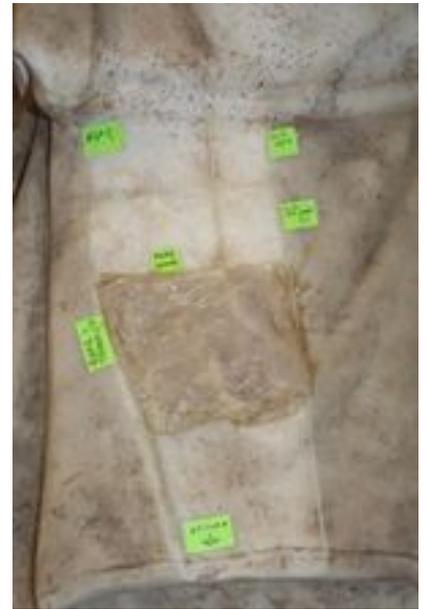
The total cleaning was performed in respect to the original patina and to the subtle traces of red and brown coloring that were found in some locks of the hair and behind the lobes.

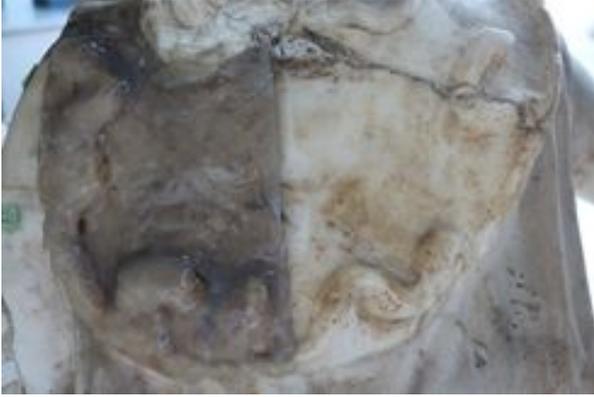
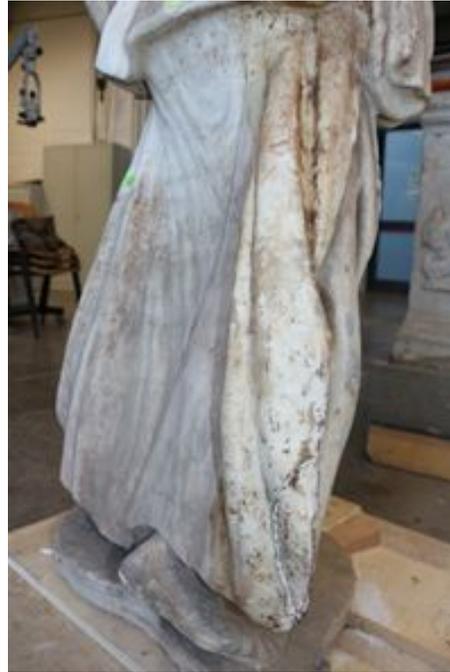
The cleaning with the Agar-Agar has allowed a removal of the coherent and incoherent deposits respecting the “noble patina” on the marbled surfaces.
